DEPARTMENT OF TRANSPORTATION

Quality Assurance and Source Inspection

Contract #: 04-0120F4Cty: SF/ALA Rte: 80 PM: 13.2/13.9File #: 1.28**WELDING INSPECTION REPORT****Resident Engineer:** Casey, William**Address:** 333 Burma Road**City:** Oakland, CA 94607**Report No:** WIR-029079**Date Inspected:** 28-Jan-2013**Project Name:** SAS Superstructure**OSM Arrival Time:** 700**Prime Contractor:** American Bridge/Fluor Enterprises, a JV**OSM Departure Time:** 1730**Contractor:** American Bridge/Fluor Enterprises, a JV**Location:** Job Site**CWI Name:** See below.**CWI Present:** Yes No**Inspected CWI report:** Yes No N/A**Rod Oven in Use:** Yes No N/A**Electrode to specification:** Yes No N/A**Weld Procedures Followed:** Yes No N/A**Qualified Welders:** Yes No N/A**Verified Joint Fit-up:** Yes No N/A**Approved Drawings:** Yes No N/A**Approved WPS:** Yes No N/A**Delayed / Cancelled:** Yes No N/A**Bridge No:** 34-0006**Component:** Tower**Summary of Items Observed:**

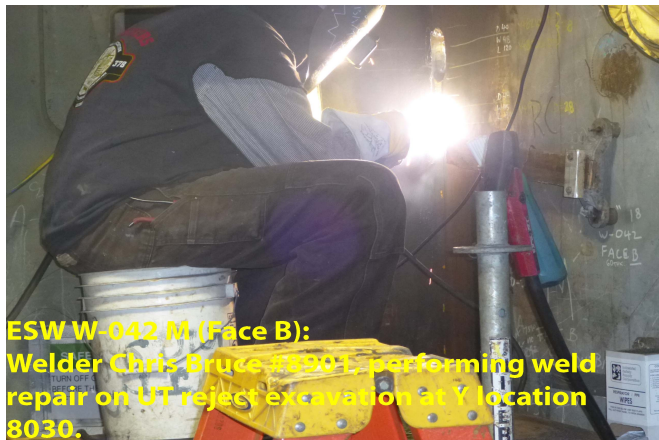
The welder was observed performing weld repair on the reject excavation on the Electro Slag Weld ESW W-042 "M" at Face B. The indication was rejected with Ultrasonic Testing Shear Wave and excavated at Y location 8030 as per the Request for Weld Repairs or the RWR 201301-040. The welder was observed preheating the weld to 300 degrees Fahrenheit prior to welding using the heat induction blankets with the Miller Pro Heat 35. The welder utilized the Welding Procedure Specification (WPS) ABF-WPS-D15-1000-Repair Rev.3 for Shield Metal Arc Welding (SMAW). The welding parameters were verified by QC Inspector William Sherwood throughout the day and they appeared to be in compliance with the WPS noted above.

ESW W-042 M (Face B):
Welder Chris Bruce #8501, performing weld repair on UT reject excavation at Y location 8030.

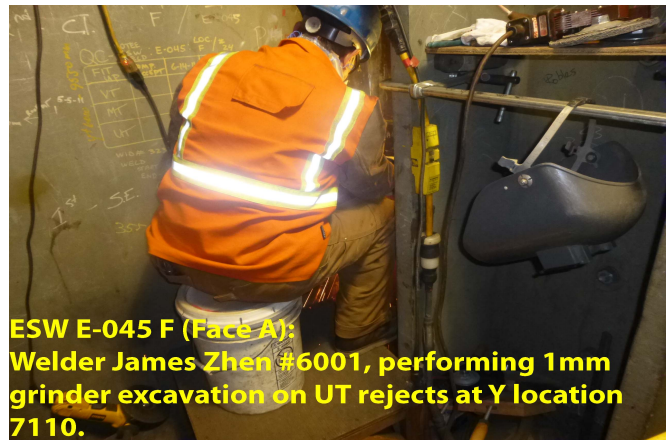
The welder was observed excavating the weld ESW E-045 "F" at face A, in 1mm increments at the Y location 7110. Each of the 1mm excavation was performed with a grinder and was Magnetic Particle Tested (MPT) and photographed by QC Inspector William Sherwood and this QA. The excavation continued at 14mm deep from the previous shift until a depth of 21mm at the end of the shift. The grinding of the excavation will continue on the following shift. The welder was observed grinding the entire shift.

o 1mm incremental excavation at Y 7110 from 14 to 21mm deep. (MPT Reject)

ESW E-045 F (Face A):
Welder James Zhen #6001, performing 1mm grinder excavation on UT rejects at Y location 7110.
